Regional Transportation District

Memorandum

Subject: GMR 8961, Supplemental Information, West Corridor Fencing and Barriers

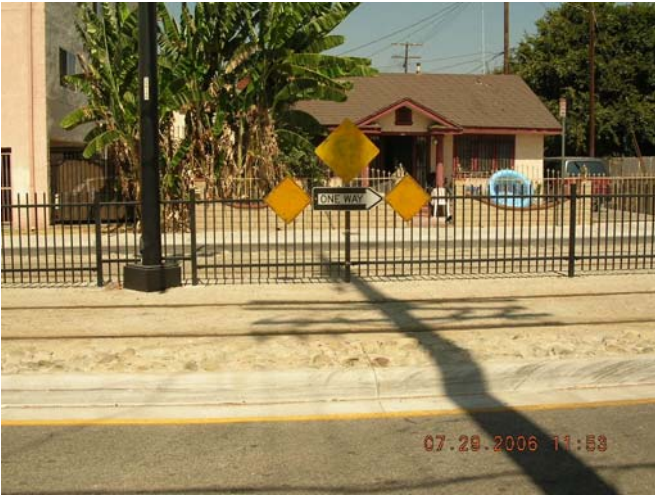
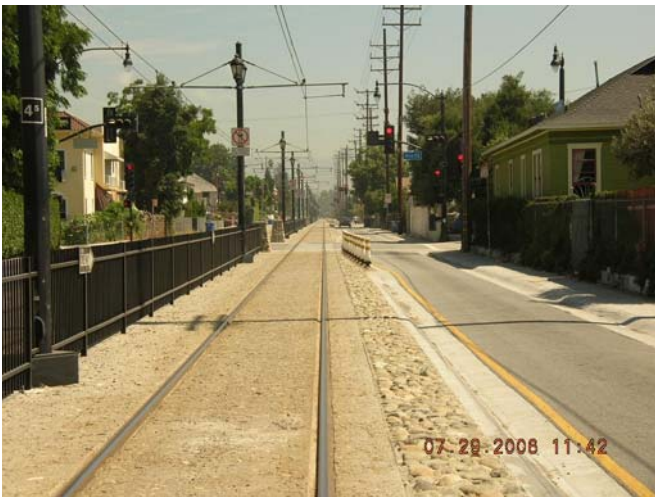
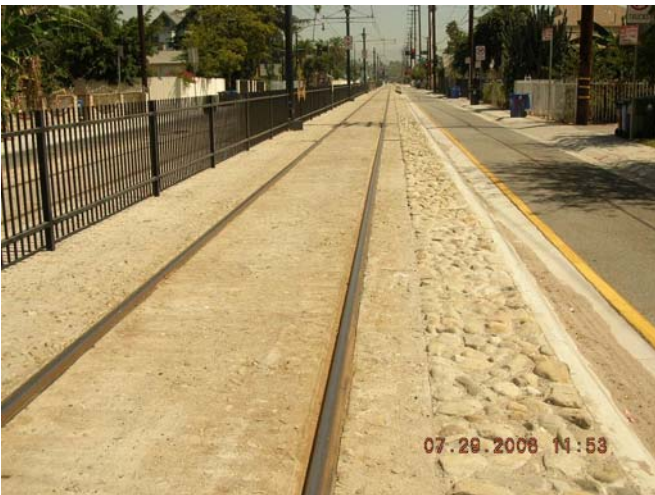
LA MTA Gold Line, maximum operating speed is 20 mph, note center steel picket fence

The LA MTA utilizes various fencing and barriers throughout their light rail system. Of particular note is their use of steel picket fencing, ornamental iron fencing, wire mesh fencing and vinyl-clad chain link fencing in slow speed operating environments (some with maximum train speeds of 20 mph). LA MTA uses some type of fence in every operating environment with the exception of street running. However, they are currently revisiting certain street running environments and proposing center median fencing to address pedestrian

crossing, jaywalking and trespassing. LA MTA's pedestrian crossing and trespass experience on the Blue Line led them to utilize ROW fencing on the newer Gold Line to address the types of problems encountered with pedestrians on the Blue Line. The fencing in slow speed areas of the Gold Line has been so effective in addressing pedestrian problems that the LA MTA has installed center median fencing on the Blue Line. LA MTA is also in the process of installing additional center or median fencing for street running sections of the Blue Line in Long Beach where train speeds do not exceed 35 mph.

Photographs showing LA MTA's various operating environments and fencing are included in the attachment (pages 7-9).

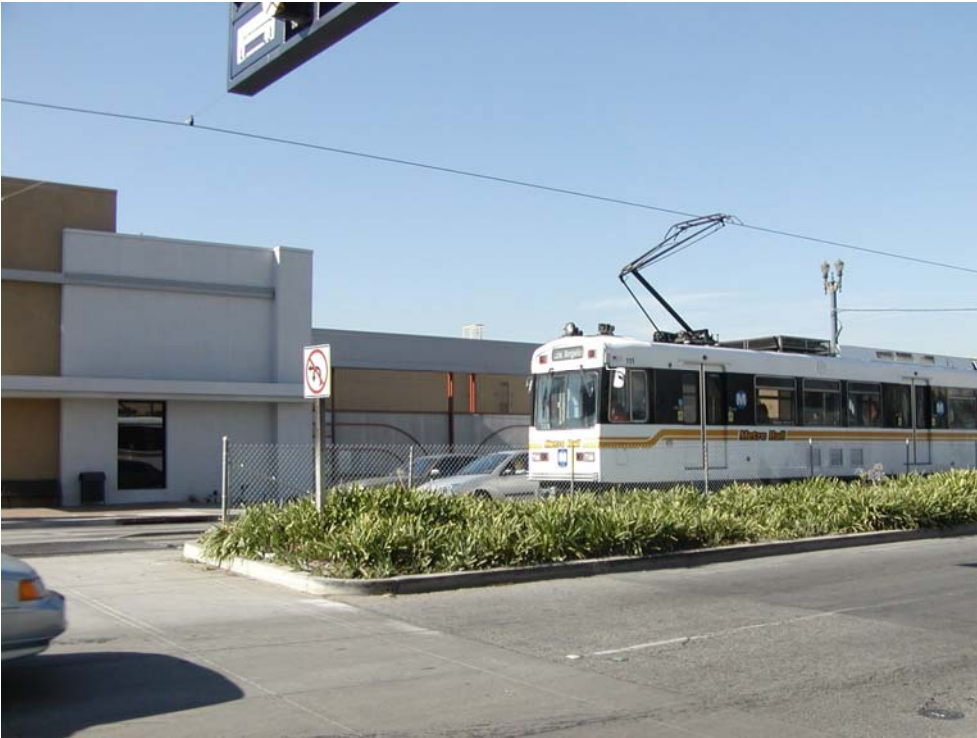
LA MTA Blue Line, street running environment, maximum speed 35 mph, note center chain link fence

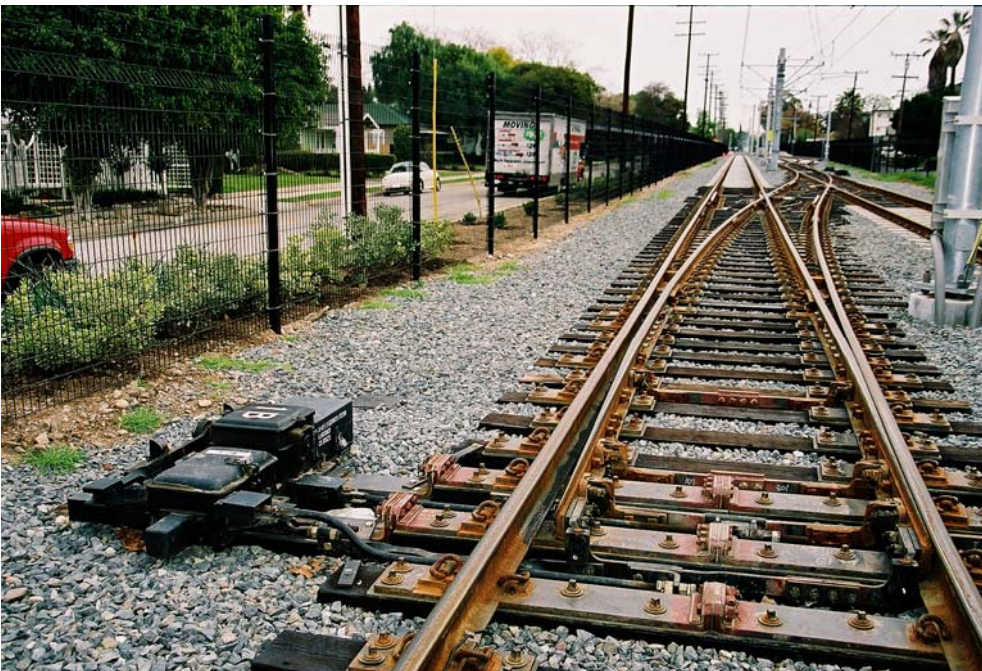
Other examples of LA MTA fencing, wire mesh

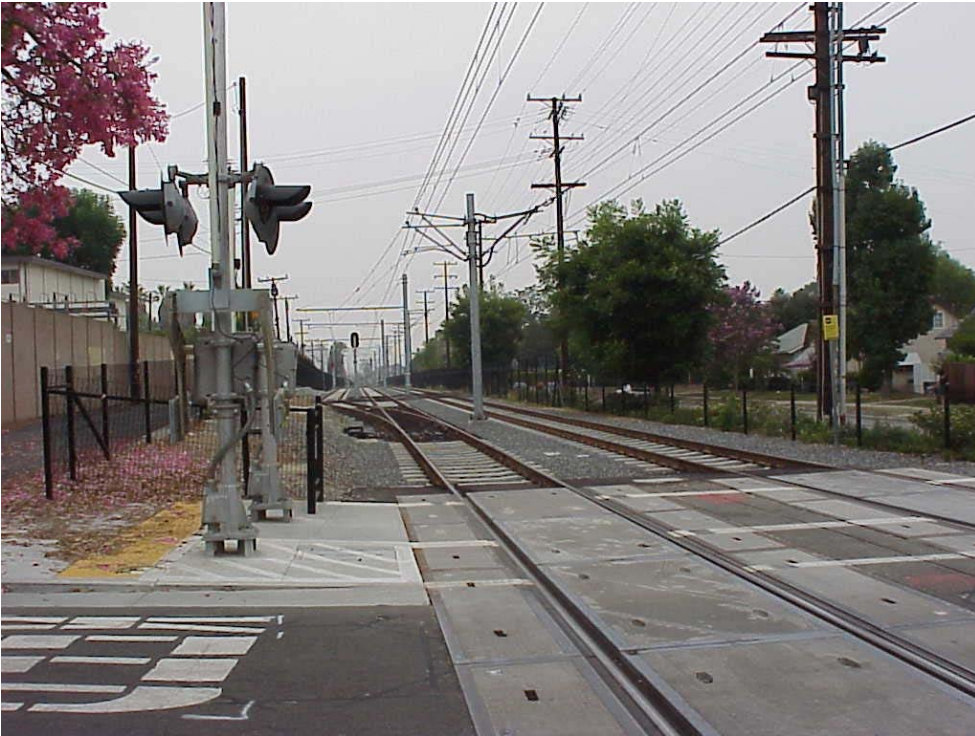
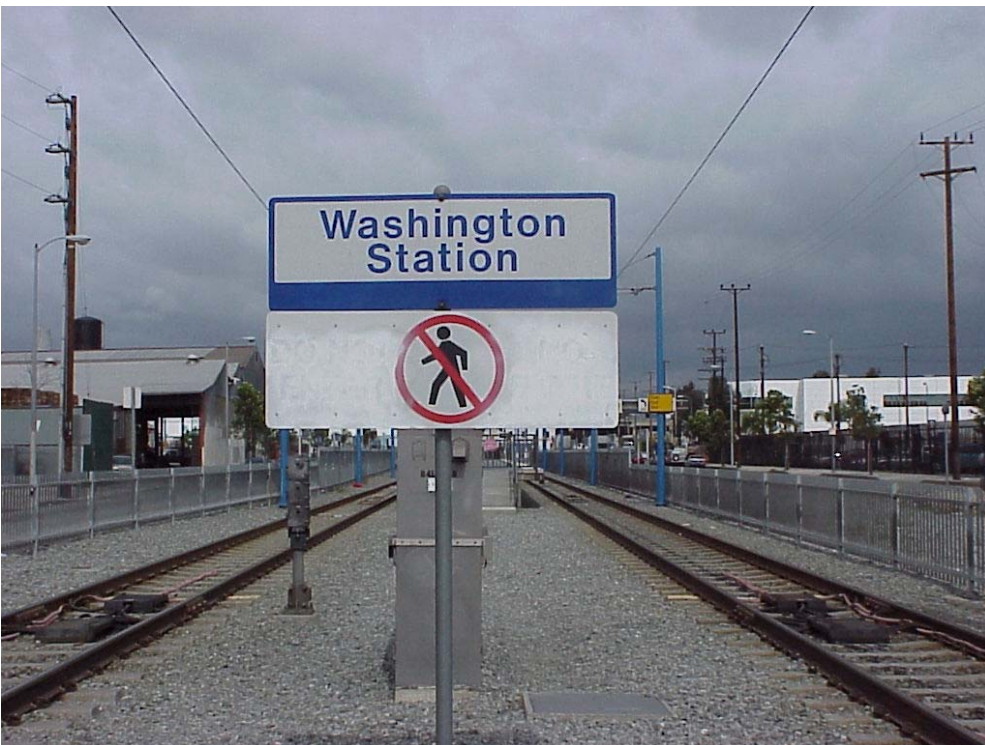
Other examples of LA MTA fencing, wire mesh and steel pickets

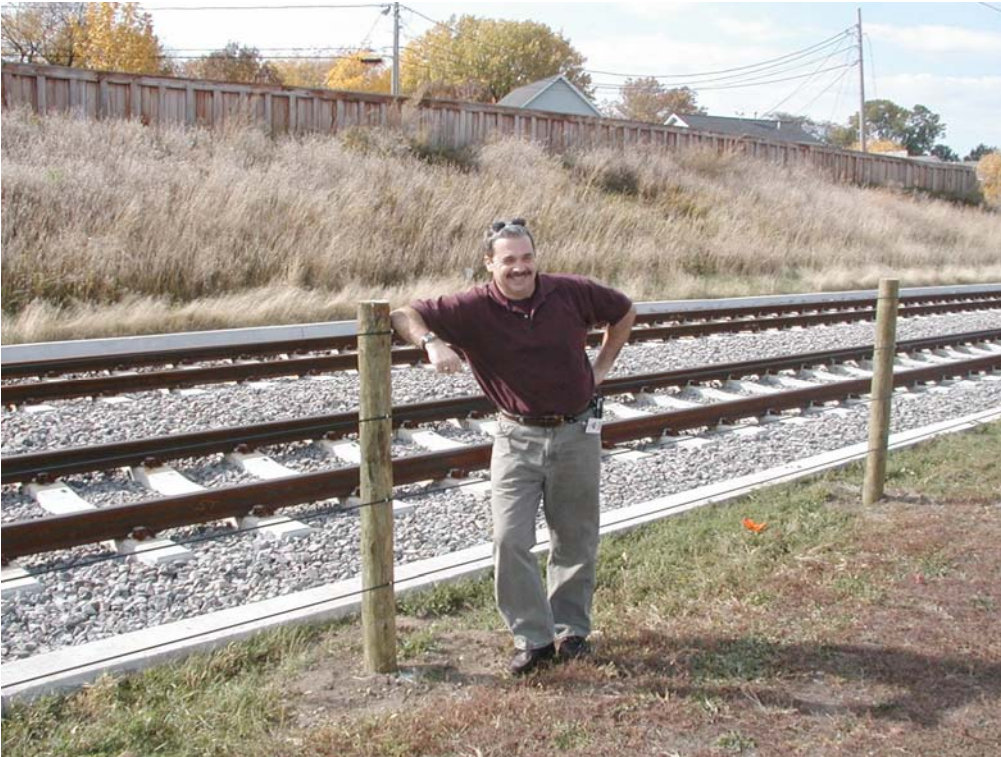
Minneapolis/St. Paul Metro Transit, 4-cable wooden post fence

Metro Transit utilizes various types of ROW fencing depending on the operating environment. The ROW fencing has been effective in preventing pedestrian accidents and has been effective in preventing pedestrian trespass in the ROW. Along the Hiawatha section, Metro Transit uses industrial type wooden privacy fencing where the alignment operates adjacent to back yards. Throughout the majority of their system, Metro Transit uses ROW fencing made from wooden posts with 4 horizontal cables. A photo of this fencing is included in the attachment (page 10). In the Downtown East section, Metro Transit experienced trouble with pedestrian movement across tracks in stations. Metro Transit installed 48 inch vinyl-coated chain link fence in the center of the tracks and it has been very effective in preventing pedestrian movements across the tracks. They are currently working on installing more fencing between the tracks to protect pedestrians from the second train scenario.

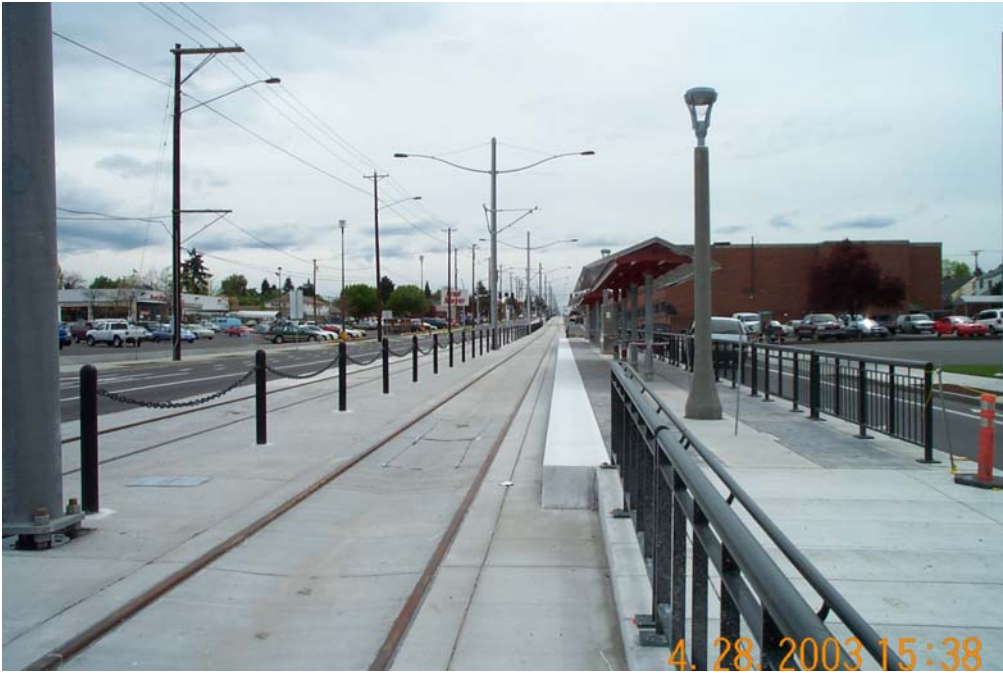
Portland Tri-Met, bollard and chain barrier on Interstate Max

opened Interstate Max (yellow line) for example, Tri-Met installed center bollard and chain barriers that have proven very effective at preventing and reducing pedestrian trespass and pedestrian accidents. The operating speed of this section is 35 mph. A photo of the barrier is included in the attachment (page 11). Tri-Met also revisited their existing alignment in the Skidmore area near downtown because of continuous problems with pedestrians. They placed historic-looking bollards and chains in this area which have proven effective at preventing and reducing pedestrian trespass and pedestrian accidents. Along Tri-Met's east side (Gresham) the operating speed is 35 mph and there are currently no ROW fencing or barriers, however, they recently had a pedestrian fatality in this section. Their experience with pedestrian migration and trespass in this area is very high and Tri-Met would like to place bollard and chain center barriers to reduce pedestrian trespass. Tri-Met stated that for all new light rail alignments, their preference is to use bollard and chain.

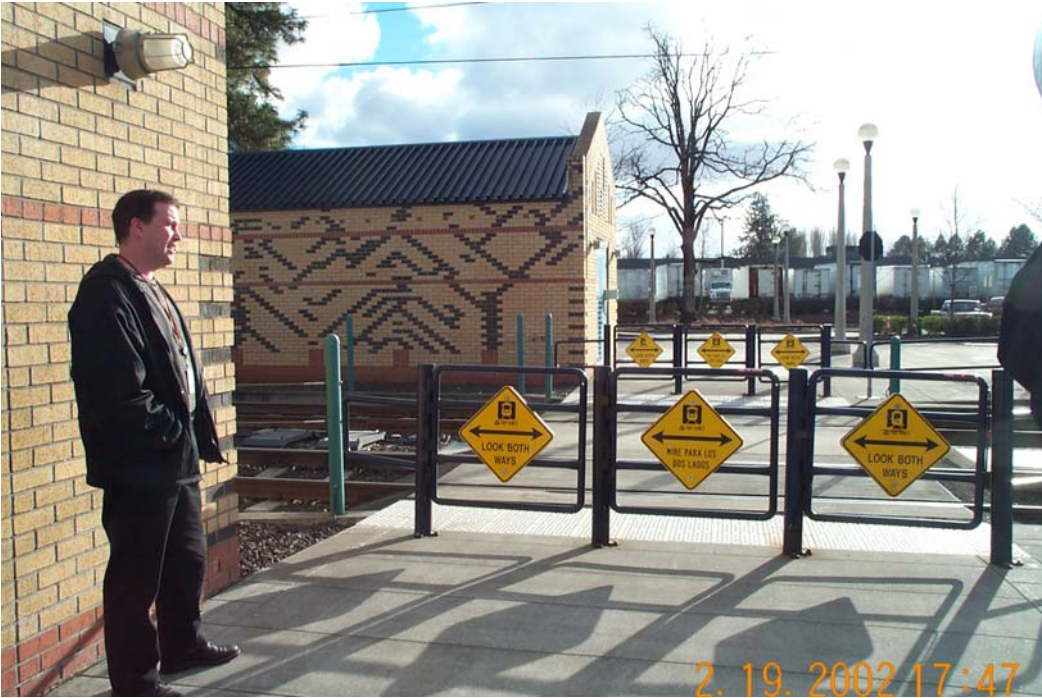
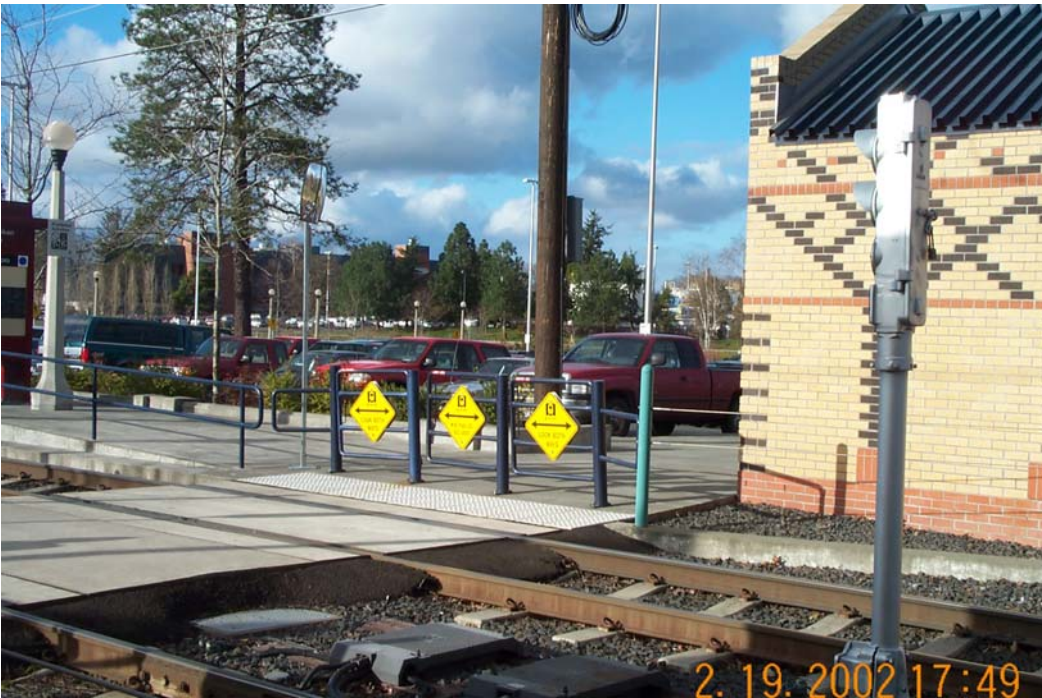
Portland Tri-Met, pedestrian railing, cables and swing gates

Tri-Met also experienced several serious pedestrian accidents including at least one fatality in the Beaverton area of the blue line (Hillsboro). In response to these accidents, Tri-Met installed railing, cabling and pedestrian swing gates to channel pedestrians to safe crossing areas instead of letting them cross the tracks in any area. Photos are included in the attachment (pages 12-13).

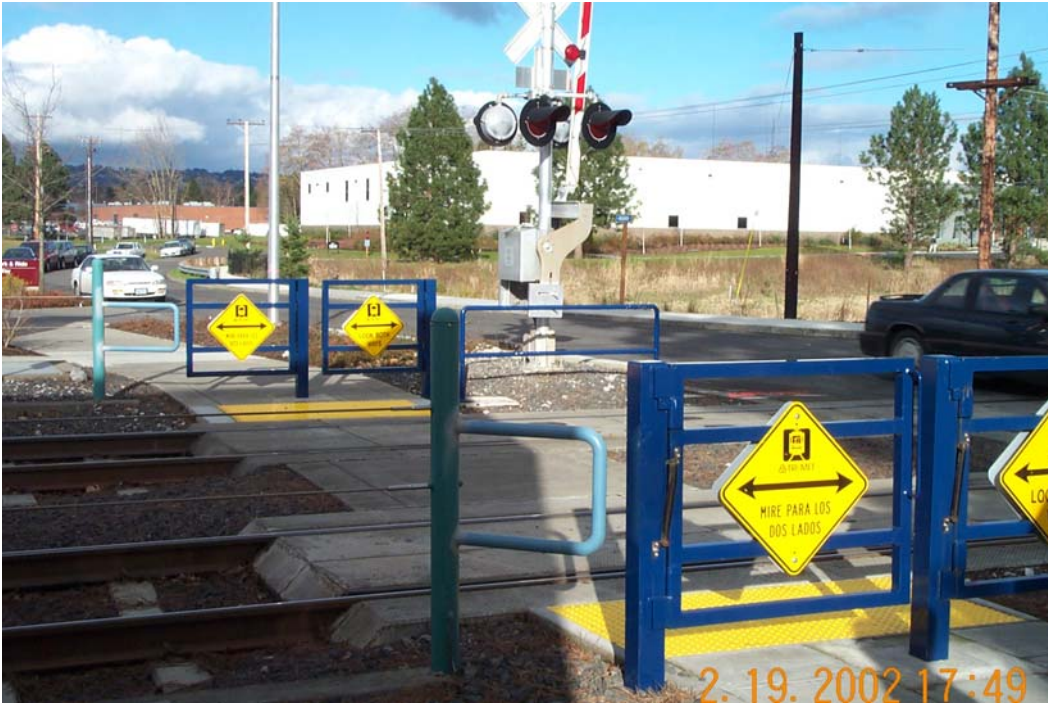
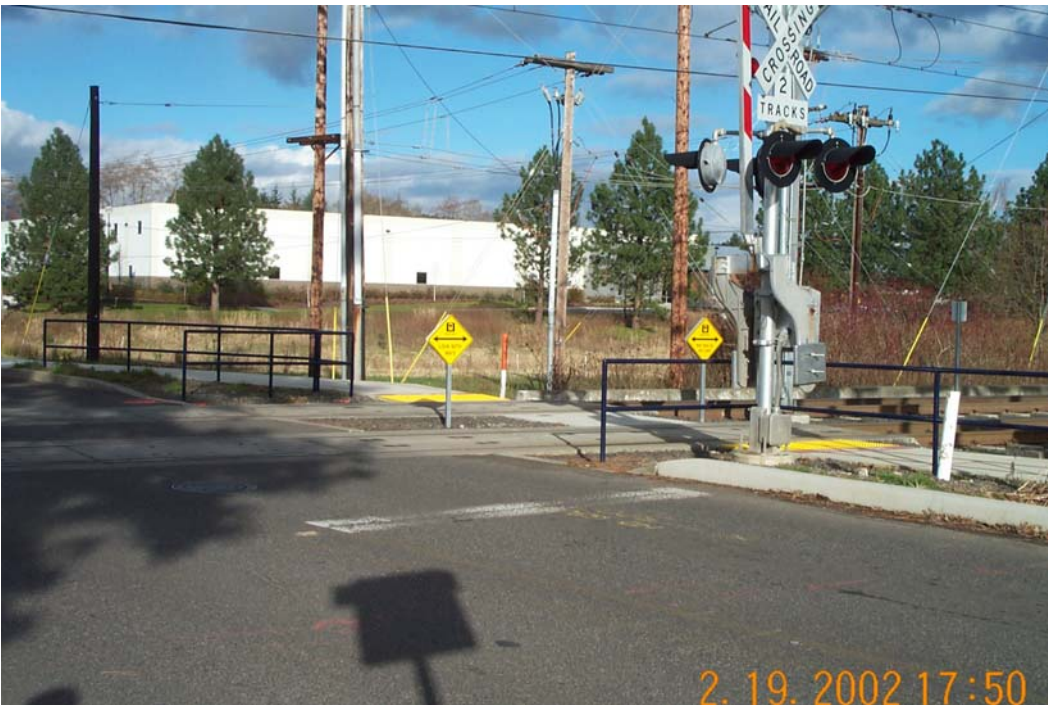
Portland Tri-Met, additional photos showing cable fencing, swing gates and railing

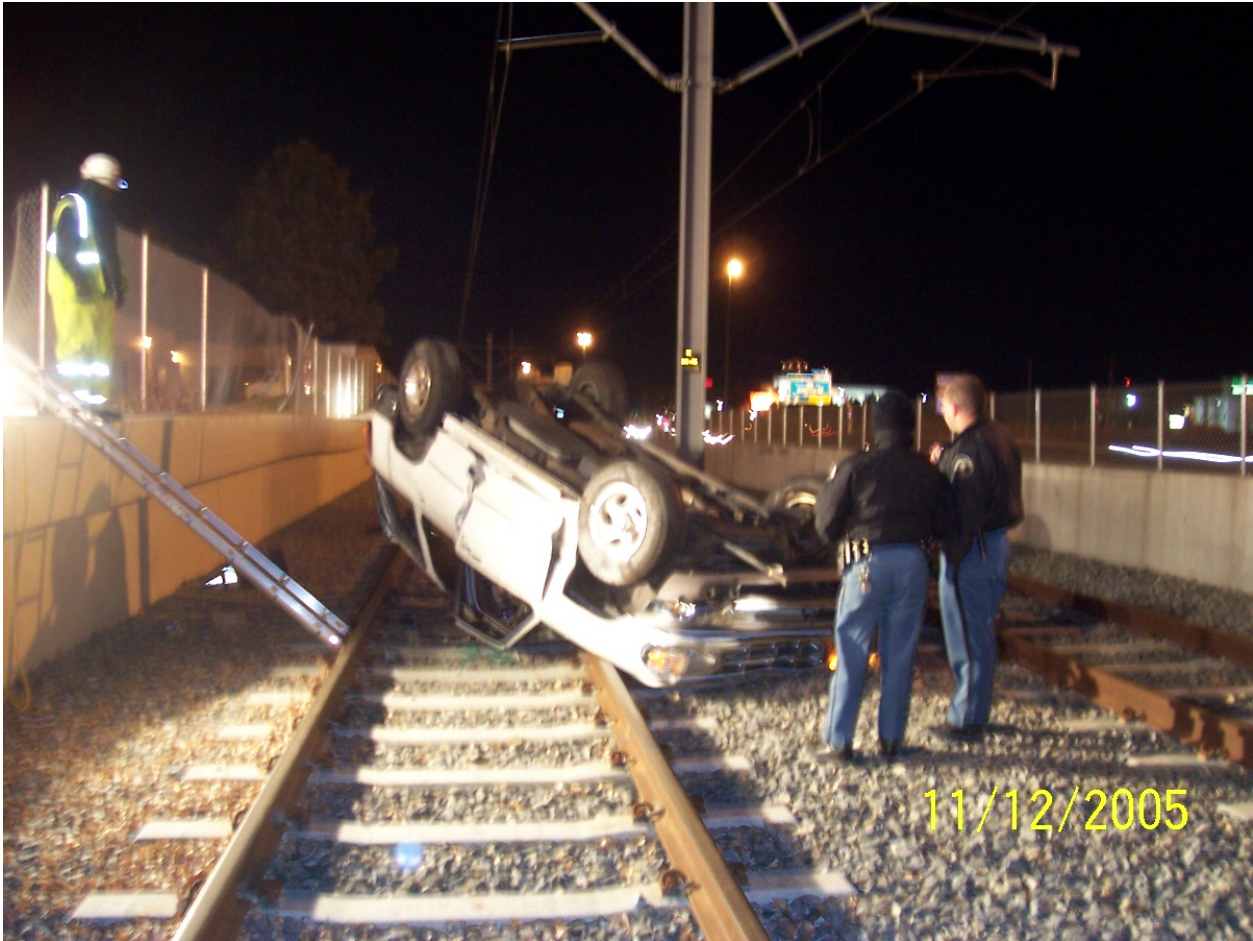
Denver RTD, automobile went through fencing and into Southeast Corridor rail alignment. The automobile came from the west side (not the highway side) from a parking lot road approximately 50 feet from the ROW. A concrete barrier was added after the accident.

It is common industry practice to utilize various types of fencing and barriers along light rail alignments. The use of fencing and barriers is for several reasons: to reduce and prevent pedestrian trespass and pedestrian accidents in the rail right-of-way; and to prevent vehicles from inadvertently entering the rail right-of-way resulting in auto/train accidents. Secondary to safety, incidents in the rail right-of-way cause significant service interruptions and delays in service (refer to photo on page 14).
