# 100-Year Floodplain in the Gold Line Corridor

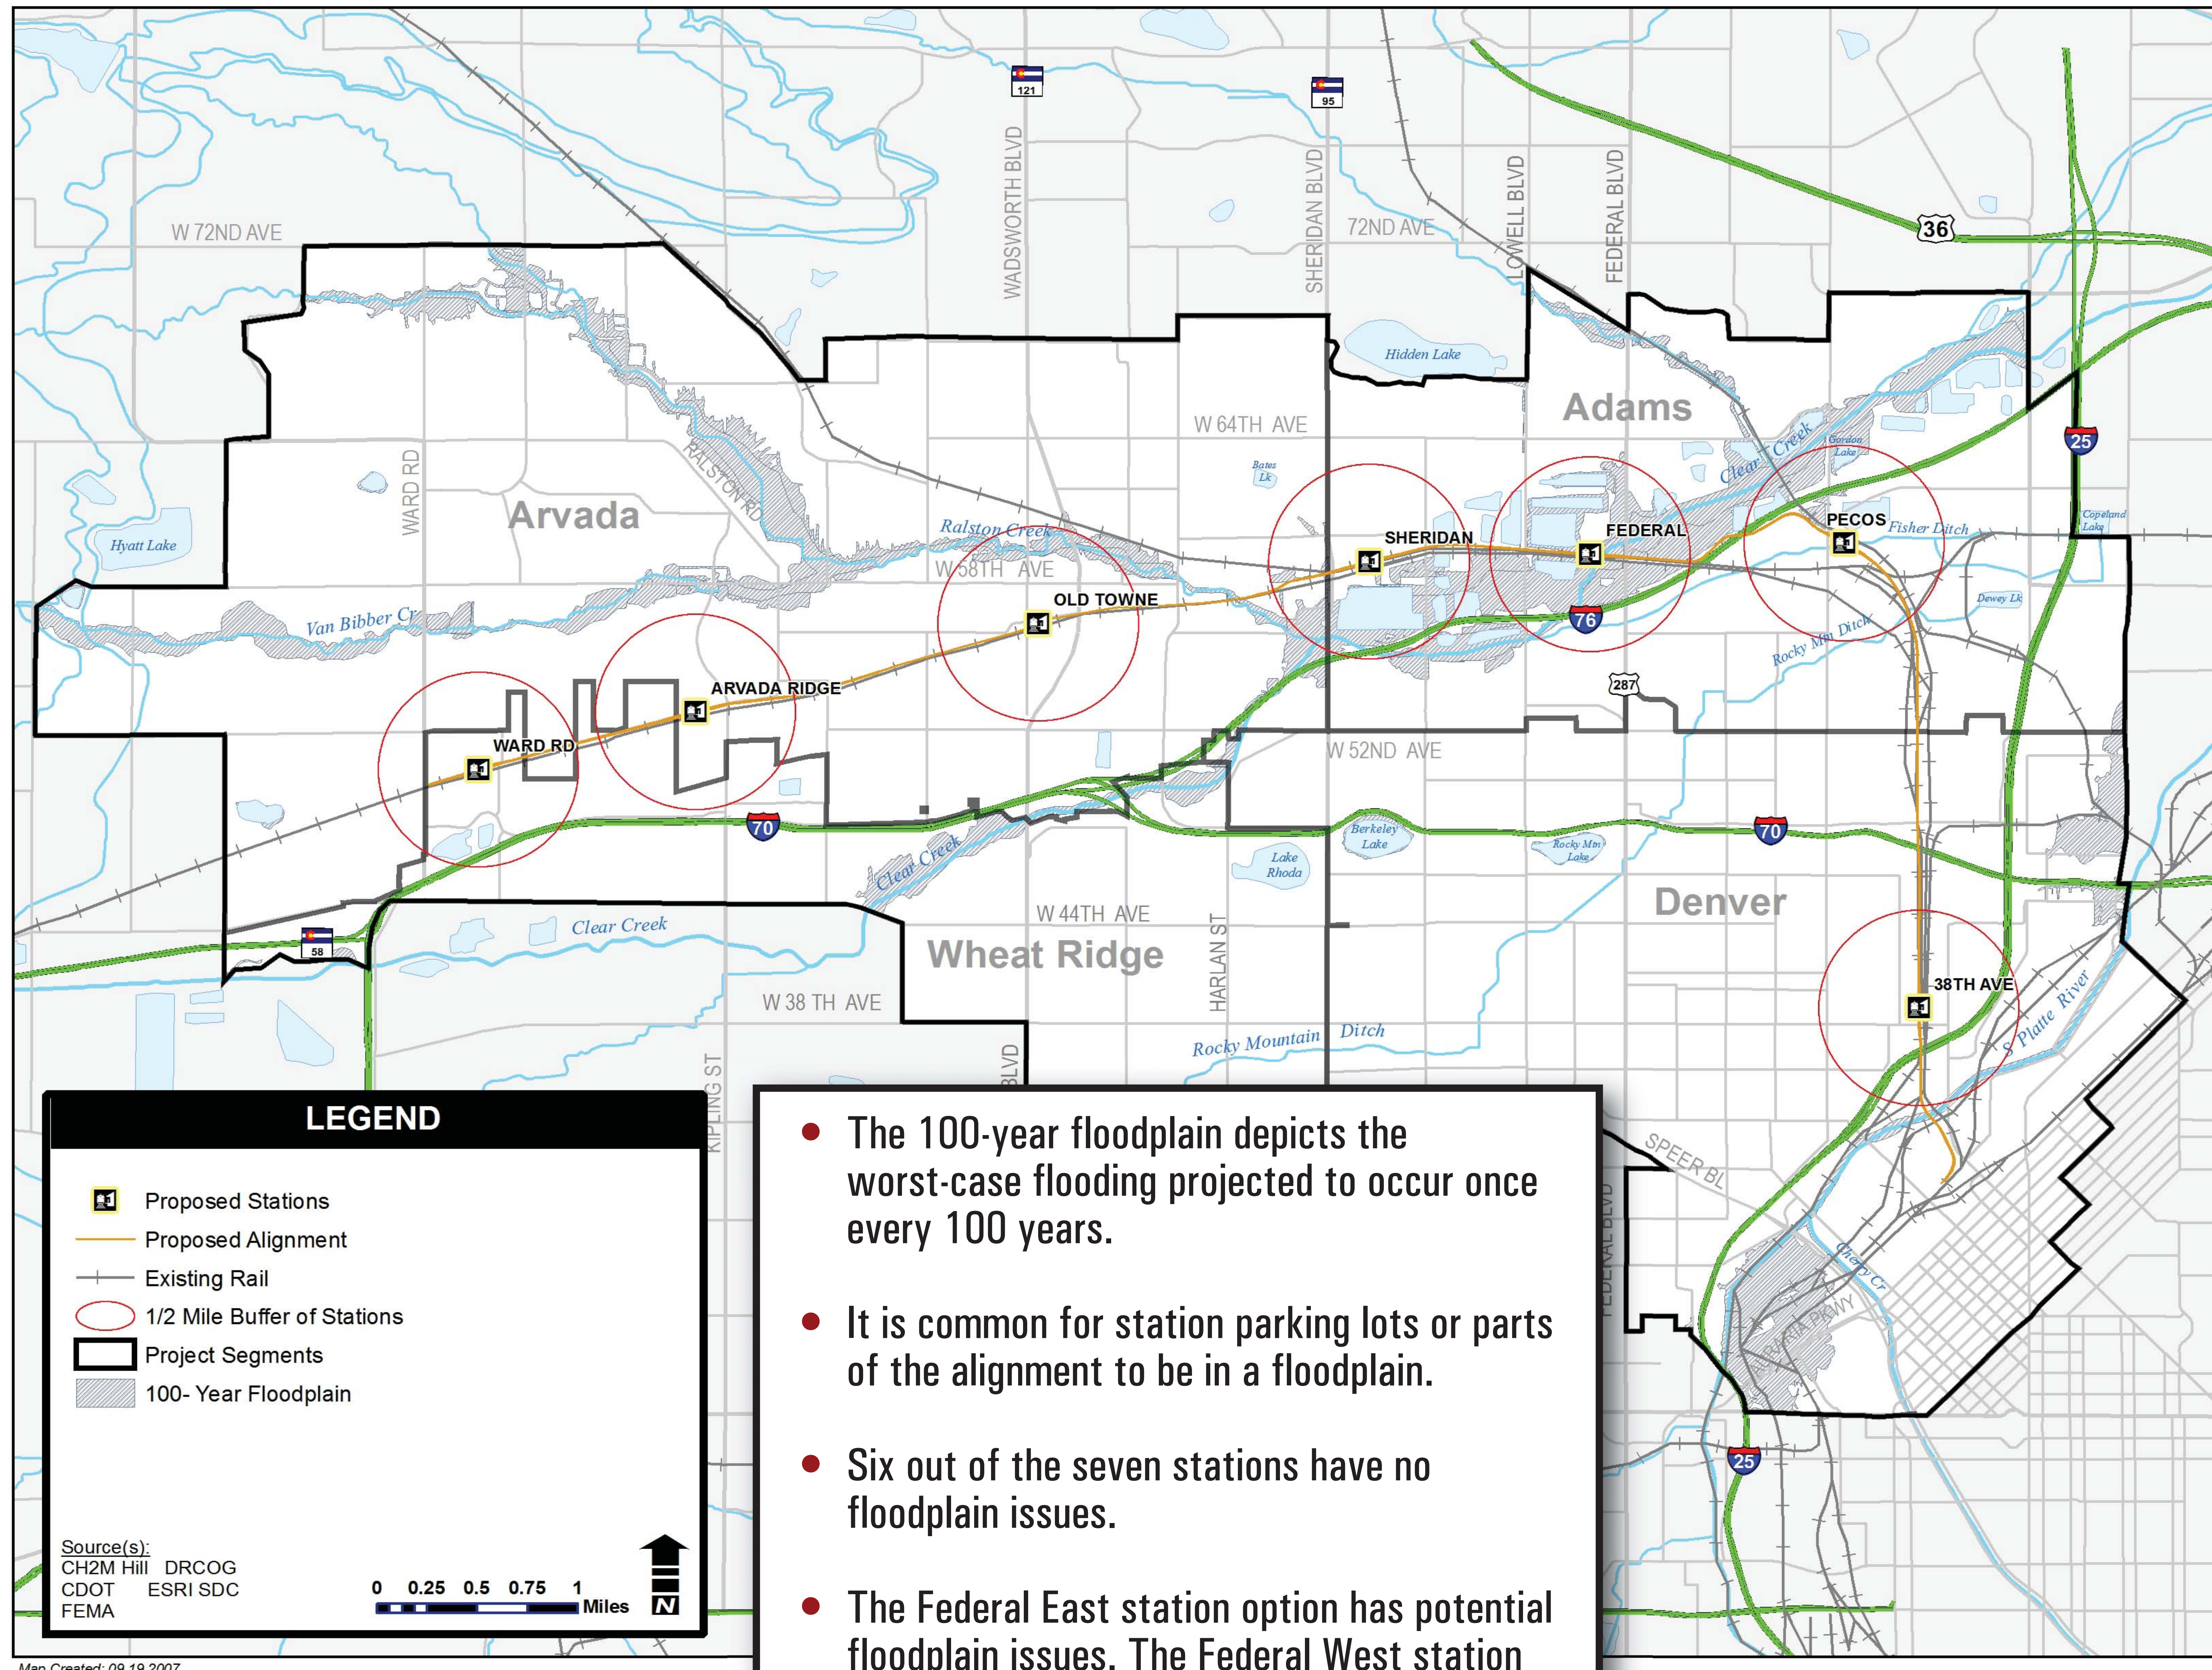
- The 100-year floodplain depicts the worst-case flooding projected to occur once every 100 years.
- It is common for station parking lots or parts of the alignment to be in a floodplain.
- Six out of the seven stations have no floodplain issues.
- The Federal East station option has potential floodplain issues. The Federal West station option may not have floodplain issues, but additional analysis is being conducted to confirm.
